Background

Dunmore School District, located in Lackawanna County, serves approximately 1,500 K-12 students.

Project Summary

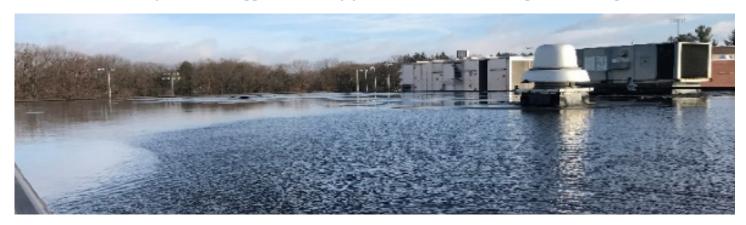
Dunmore Elementary School struggled for many years with malfunctioning roof drainage, shown below:

Water remained on the roof, creating several inches of standing water (or ice), as well as leaks within the building.

Dunmore's performance contract project tackled the main health risk of the leaking roof, while simultaneously increasing the R-value of the roof. It also included the relocation and addition of drains to address the drainage problems. And, the project involved the replacement of the gas piping which was in poor condition, due to the standing water, as well as age.
