# Optimization Services

## Project: Middle Township Fire Department

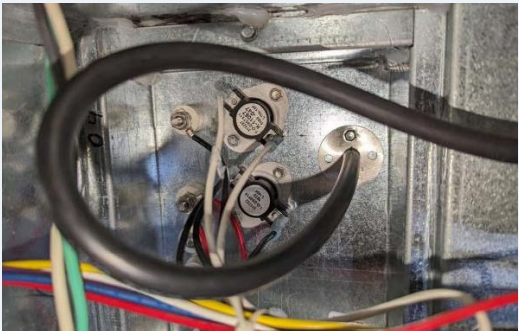
**ISSUE 010**  
PROJECT / EQUIPMENT / VAV7

Found VAV set for a common set point of 80° F. The VAV was calling for two stages of heating with no increase in discharge. Further diagnosis shows a high limit switch open and in need of replacement.

**Recommend replacement of high limit disc and verification of heat operation.**

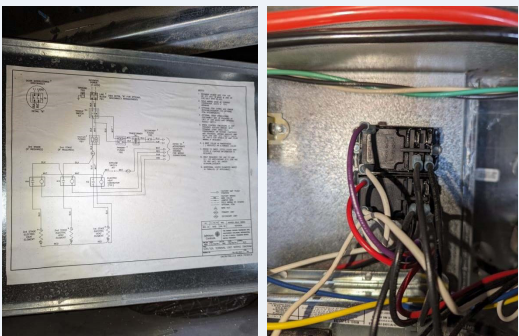
**ISSUE 011**  
PROJECT / EQUIPMENT / VAV6

Loud humming heard from inside the line voltage cabinet when heating is enabled. No rise in discharge was noted with both stages calling.

**Recommend replacement of heating contactor and verifying unit operation.**
