# Performance Contracting Project: Roof Replacement

How one school district combined ESSER funding with Pennsylvania's **Guaranteed Energy Savings Act** to obtain a full roof replacement for their elementary school.

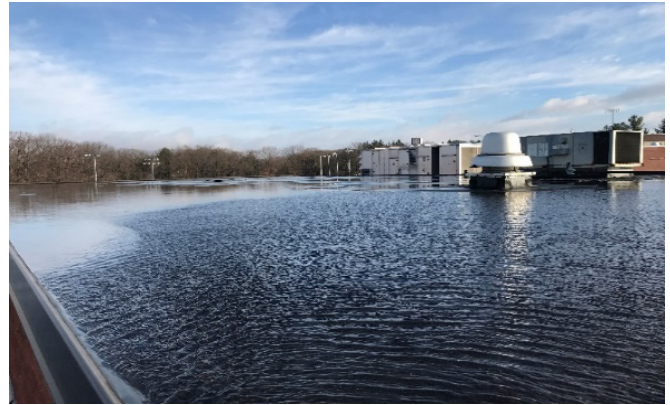
**Water remained on the roof, creating several inches of standing water (or ice), as well as leaks within the building.**

*Dunmore Elementary School struggled for many years with malfunctioning roof drainage, shown above:*

Dunmore's performance contract project tackled the main health risk of the leaking roof, while simultaneously increasing the R-value of the roof. It also included the relocation and addition of drains to address the drainage problems. And, the project involved the replacement of the gas piping which was in poor condition, due to the standing water, as well as age.

While CM3 provides both full roof replacements and rehabilitations, for Dumore School District, CM3 conducted a complete tear-off of the existing roof system, including all sheet metal flashing down to the existing deck.

- » Reuse existing wood blocking to the greatest extent possible to reduce overall cost where possible.
- » Add tapered insulation to improve energy efficiency.
- » Add non-reinforced EPDM membrane.
- » Add new blocking to edges and curbs to meet new insulation heights.
- » Relocate drainage and add more drainage, as needed.
- » Install new aluminum edge around the perimeter of the building.
- » Supply and install new scuppers at the perimeter to aid in drainage.
- » Furnish a 20-year warranty on the roof.
